# Manhole Inspection Summary

Manhole # S15C\_\_027MH

**Location** Address: **2636 LAURETTA-FRANKLIN** Cross Street: **ASHBURTON ST**

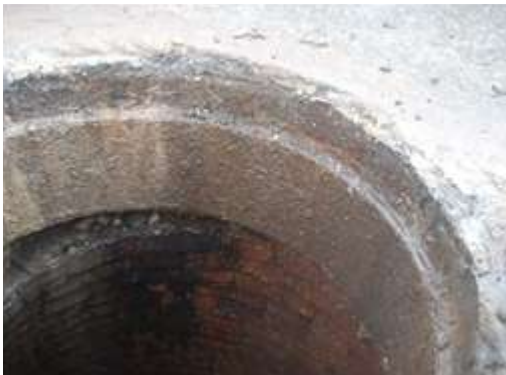
Defect 3

**Chimney / Frame Adjustment** ☒ Exists Material: **Brick** ☐ Parged Height: **6** (in.)  
Condition: ☐ Sound ☐ Cracked ☐ Root Intrusion ☒ **Loose Brick** ☒ **Deteriorated**  
Infiltration: ☐ None ☒ **Joint** ☐ Cracks ☐ Mortar ☐ Roots ☒ **Wall**

CHIMNEY INFILTRATION

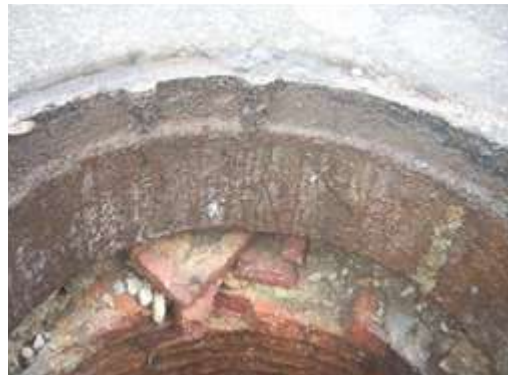
Defect 2

CHIMNEY DETERIORATION

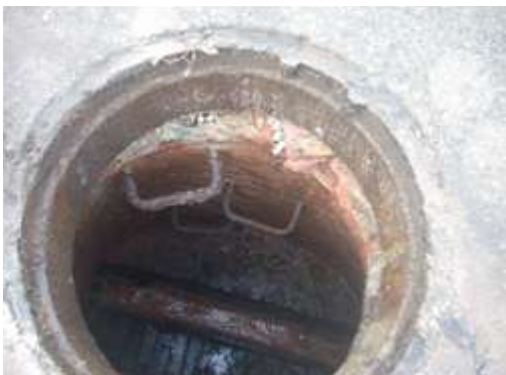
Defect 1

**Steps** Count: **3** Missing: **0** ☒ **Corroded**

CORRODED STEPS

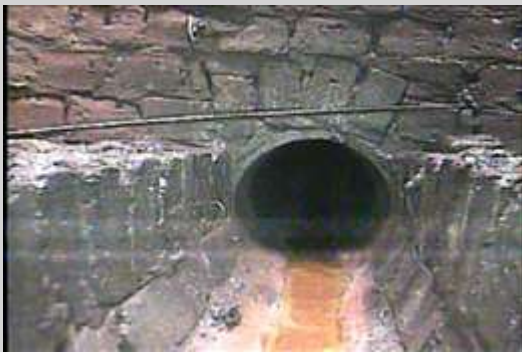
12 O'Clock Outflow

8 in. Circular Gravity Sewer  
Pipe Out @ 12 O'Clock

Pipe Height: **7.2** (in.) Rod and Bar (Angled)  
Pipe Material: **Clay** ☐ Pipe Lined  
Invert Depth: **6.29** (ft.) Flow Characteristics: **Slow**  
Deposits: ☒ None ☐ Mud ☐ Sludge ☐ Debris ☐ Grease  
Silt Depth: (in.) Deposits Extent:  
Infiltration: **None** Pipe Seal Cond: **Sound**

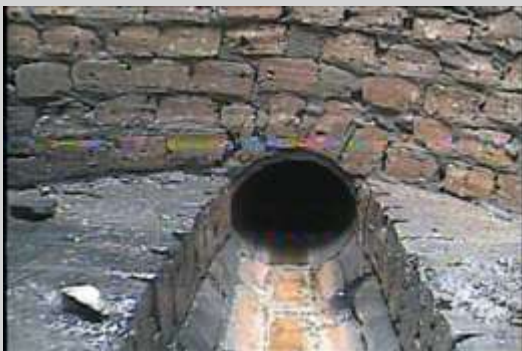
6 O'Clock Inflow

8 in. Circular Gravity Sewer  
Pipe In @ 6 O'Clock

Pipe Height: **8.4** (in.) Rod and Bar (Angled)  
Pipe Material: **Clay** ☐ Pipe Lined  
Invert Depth: **6.18** (ft.) Flow Characteristics: **Slow**  
Deposits: ☒ None ☐ Mud ☐ Sludge ☐ Debris ☐ Grease  
Silt Depth: (in.) Deposits Extent:  
Infiltration: **None** Pipe Seal Cond: **Sound**
